DAMAGE ANALYSIS OF CONDENSER COOLING TUBES IN A THERMAL POWER PLANT

Dušan Strušnik¹✉, Jurij Avsec²

Keywords: ammonia, cooling, cracks, tubes

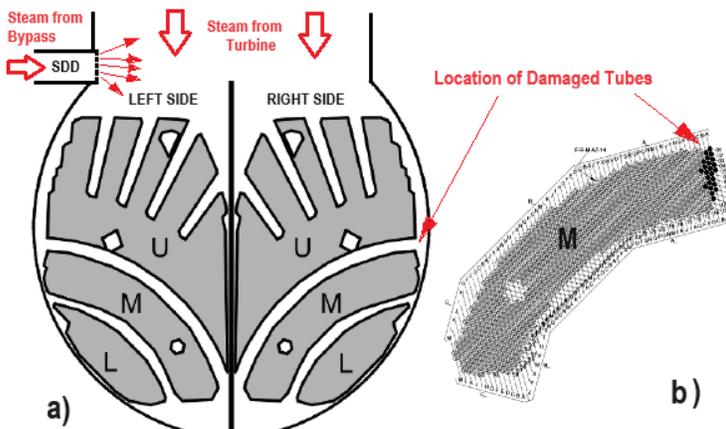
The STC tube bundle is divided into left and right sides, and each side of the tube bundle is divided into 3 sectors: upper (U), middle (M) and lower (L). The tube bundle sides, tube bundle sector, damaged tubes, and plugged tubes for inspection are shown in Fig. 2.

Figure 2. a): Tube bundle sectors, and **b) Damaged tubes and plugged tubes for inspection**

After the fifth hour of test operation, the Commissioning and Trial Board found a leakage in the STC cooling tubes. Additionally, online monitoring indicated high condensate conductance. Two condensate samples were taken from the STC for chemical analysis. One sample was taken before testing, and the second sample was taken during the testing procedure.

- About three rows of tubes around the affected area, including the affected area, should be replaced with thicker tubes, 23.0 x 2.0 CuZn28Sn1As;
- The ammonia content in the steam should be monitored carefully, and should be kept to 250 ppb up to 700 ppb, and the pH maintained between 9.0 and 9.3;
- The steam velocity from the SDDs should be reduced to the HEI recommended velocity.

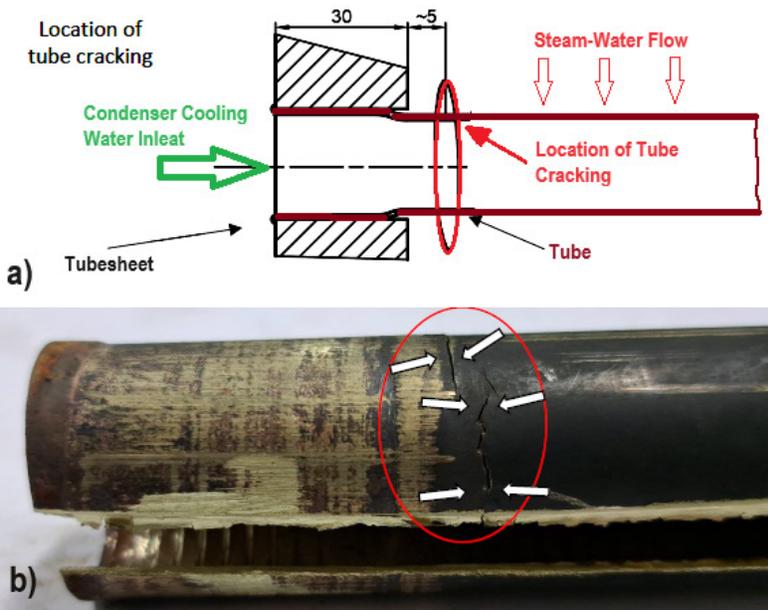
All the extracted tubes that were leaking and subsequently plugged were examined, to determine the source of the leaks. Circumferential cracks were found only at the beginning end of the tubes, near the front side. These cracks appeared approximately 3 to 5 mm after the tube sheet and were straight or slightly branched. Additionally, grooves were discovered on other tubes in the same location as the cracks found on the leaking tubes. These circumferential transverse grooves near the tube sheets are indicative of trans-granular stress-corrosion cracking, likely caused by excessive ammonia. The location of tube cracking and the cracks on the front end of the tube are shown in Fig. 3.

Figure 3. a): Location of tube cracking and b) Crack on the front end of the tube, approximately 5 mm after the tube sheet

All the cracks on the tubes that were extracted were found at the same position, approximately 5 mm from the tube sheet on the front side of the condenser, where the cooling water inlet and outlet are located. Grooves were also found on all other tubes at the same location, characteristic of stress-corrosion cracking influenced by ammonia.

These cracks and grooves were found primarily in places where the tubes were rolled into the tube sheets, indicating high stress. It is assumed that these grooves may also be caused by stress corrosion cracking under ammonia, but were either self-healed, or had not progressed to cracks yet.

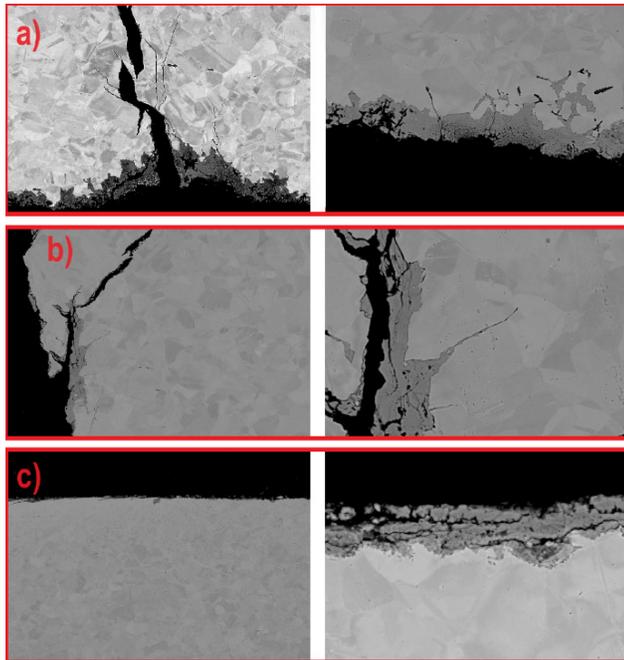
Figure 4: Examination under a microscope revealed: a) Transcrystalline progression, b) Additional cracks branching from the main crack, and c) Oxidation on the outer surface

Analysis of the tube also involved examination under a microscope. From Fig. 4, the following observations were made:

- a) The initiation of cracks on the inner surface of the pipe;
- b) The presence of multiple transcrystalline cracks;
- c) Oxidation of the outer surface with no visible marks;
- a) and b) Branched secondary cracks observed adjacent to the main crack and
- a), b) and c) Oxidation to a thickness of 50 μm .

From the results of the analyses, it can be summarised that the cracks initiated on the inner surface of the tube and progressed transcrystallinely throughout. Multiple visible cracks were observed, characterised by branching and the presence of oxides, which are common indicators of stress corrosion cracking.

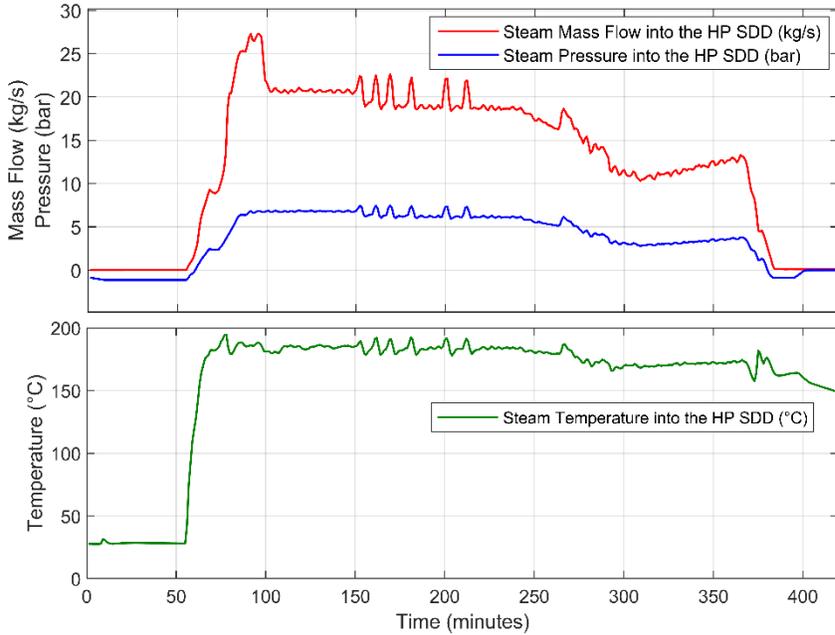
Figure 5: Quality and quantity of steam entering the HP SDDs device

Fig. 5 illustrates that, during HP SDD device operation, the incoming steam reached a maximum flow rate of 26 kg/s, with a pressure of up to 9 bar and a temperature of up to 190°C. The steam exit velocity from the HP SDD device, also known as the steam velocity entering the STC, was calculated using these data. The steam velocity from the HP SDD device was calculated using the Mach number equation. The steam Mach number is defined from the total pressure difference of the dumped steam flow and the isentropic exponent n . The velocity is calculated of the steam exiting the HP SDD device:

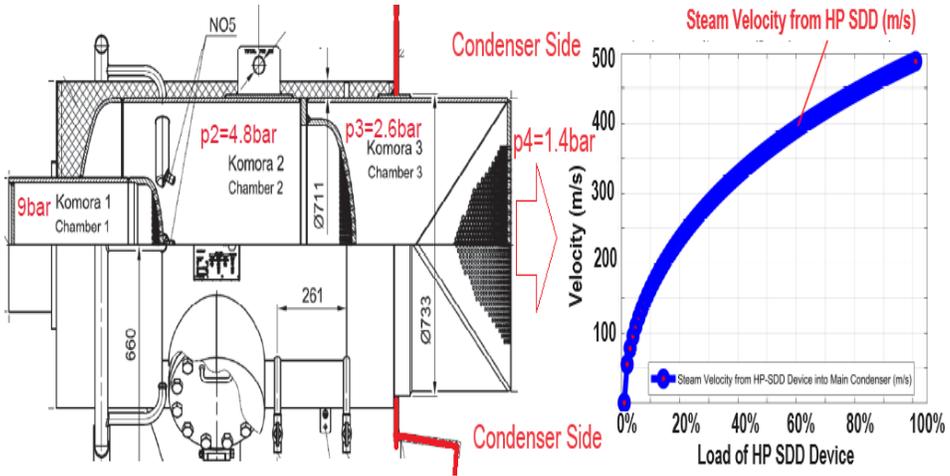
Figure 6: Design and steam velocity from the HP SDD

The results of the analysis (see Fig. 6) show that, at full load of the HP SDD, the steam velocity entering the STC was 490 m/s, exceeding the recommended steam velocities significantly. Bypass steam with excessive velocities can cause severe damage to the condenser internals. The Heat Exchange Institute (HEI) Standards for steam surface condensers provide limits for maximum enthalpy, pressure, and velocity of bypass drain or bypass steam allowed to enter into the condenser. According to the HEI, the maximum enthalpy is 2850 kJ/kg, the maximum pressure is around 18 bar, and the maximum steam velocity is around 155 m/s. Wet steam is not permitted. Damaged bypass headers, sheared tubes, and damage to internal structural members have been encountered frequently during bypass operation.

Based on the results of the analysis, it can be concluded that the damage to the STC cooling tubes was attributed to a combination of circumstances that led to stress corrosion cracking. Excessive steam inlet velocities in the STC caused large surface and resonance loads on the cooling tubes. Additionally, the excessive amount of ammonia in the condensate contributed to surface corrosion. As the cracks propagate from the inner tube to the outside, it is necessary to maintain a constant flow of cooling water.
