# ENERGY RENOVATION OF THE LETUŠ CULTURAL CENTRE

Bogdan Trop<sup>1</sup>, Franjo Pranjic<sup>2</sup>, Damjan Konovšek<sup>3</sup>, Zdravko Praunseis<sup>3\*</sup>

### **Abstract**

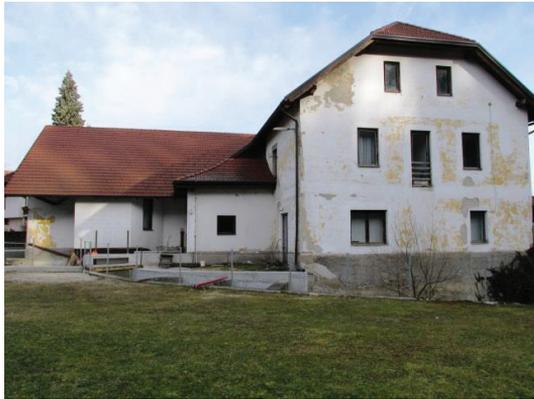
*Figure 2: Front side of the Letuš Cultural Centre*

The building was built in an L-shape with external layout dimensions of 22.25 m × 25.30 m and a ridge height of 10.3 m (Figure 1). In the NW-SE direction of the ridge, the building contains the main room, which is a one-floor hall. In the direction of the NE-SW ridge in the second part of the building is a two-floor hall. The ground floor contains an office, meeting room, handy kitchen, wardrobe, utility cleaning room, an archive and a hallway that connects all of these areas. On the first floor of this building, there are a museum and cultural society rooms. On the ground floor, there is a large glass-enclosed hall, which is not heated. Figure 2 shows the building from the front to show the architectural diversity of the building.

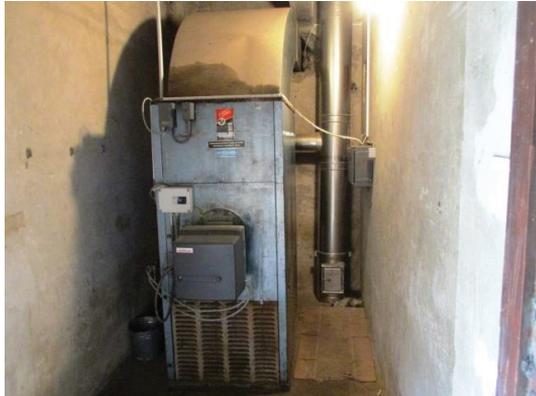
*Figure 3: Boiler room with ELFO boiler*

For heating the ground floor and the halls of the Letuš Cultural Centre, a heating system with an ELFO (Extra Light Fuel Oil) 85,000 kcal/h boiler is used (shown in Figure 3), and the heat transfer is conducted via an air-air heat exchanger. Blowing of the heated air is carried out with ducts (80 cm × 20 cm), which are routed into the hall and hallway. The water system is designed with a central air duct, which runs from the boiler room to the multipurpose hall. Air duct distribution pipes were originally not built for heating auxiliary rooms, but later an additional channel for heating of the meeting room was constructed. Control of the volume of blowing air is not carried out; in addition, steering hatches to make a selection of the heated rooms have not been installed. Hall temperature control is two-point, conducted by a room thermostat that is placed on the wall in the hall. The temperature mode of functioning is set. Other rooms have no temperature control. The ELFO system heats the hall and the ground floor. First floor rooms are not heated with this system; portable radiators are used for heating. The temperature is set manually with thermostats on eight different radiators.
